INDOOR AIR QUALITY ASSESSMENT

**Hopedale Middle/High School
25 Adin Street
Hopedale, Massachusetts**

Prepared by:
Massachusetts Department of Public Health
Bureau of Environmental Health Assessment
Emergency Response/Indoor Air Quality Program
November 2003

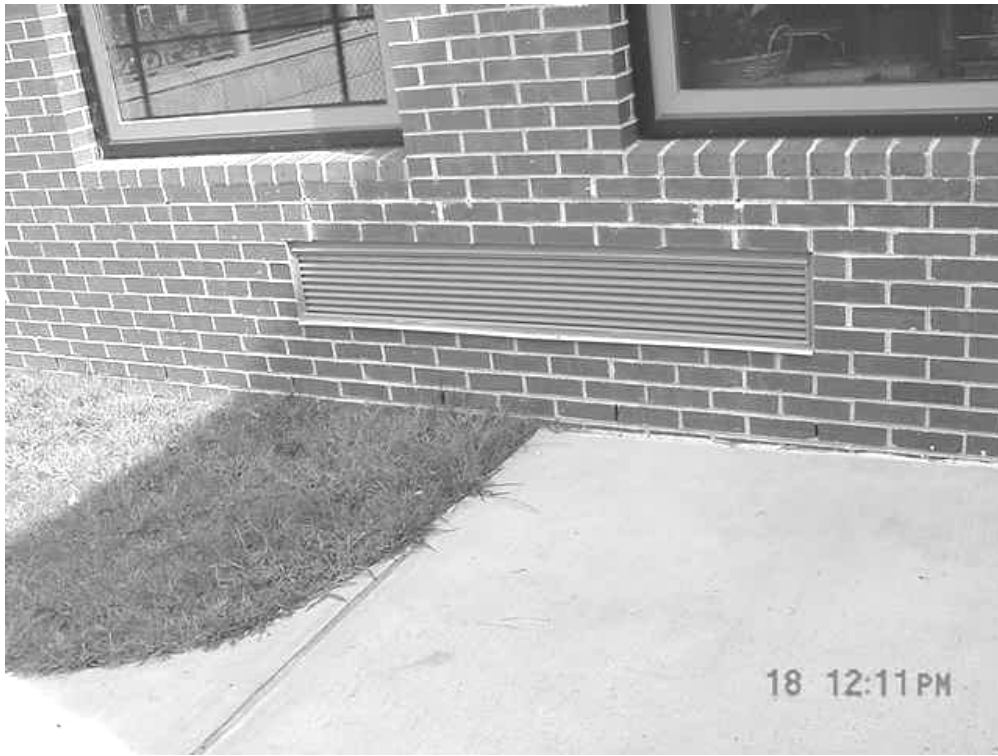
Picture 1

Fresh air in classrooms is supplied by a unit ventilator (univent) system. Univents draw air from outdoors through a fresh air intake located on the exterior walls of the building (Picture 1) and return air through an air intake located at the base of each unit ([Figure 1](#)). Fresh and return air are mixed, filtered, heated or cooled and provided to classrooms through an air diffuser located in the top of the unit. Adjustable louvers control the ratio of outside to recirculated air. As mentioned, during the air conditioning season, outside air is limited in order to maximize cooling and decrease humidity. Mr. Rinehart removed the panel to the univent to show that the univent control was set to minimal airflow (Picture 2).

Univent Outside Air Intake

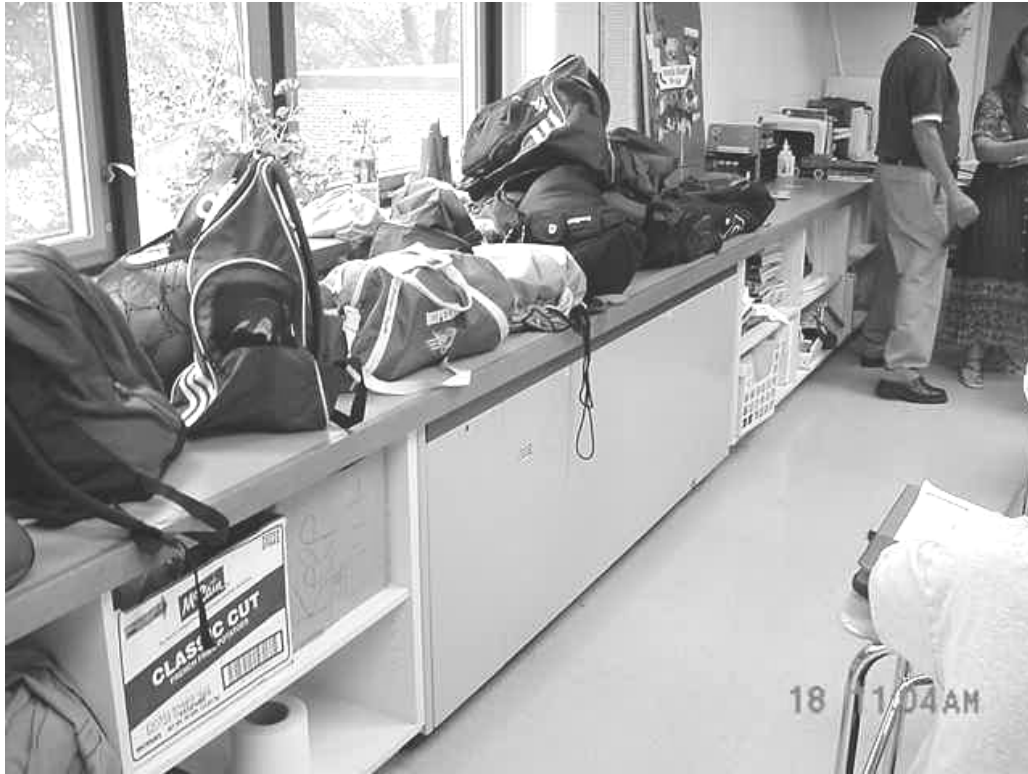
Picture 3

diffusers and return vents must remain free of obstructions. Obstructions to airflow, such as papers and books stored on univents were also seen in a number of classrooms (Picture 3).

Classroom Items on top of Univent Air Diffuser

4. Ensure univent air intakes controls are adjusted to allow the introduction of fresh air.
5. Remove all blockages from univents to ensure adequate airflow.

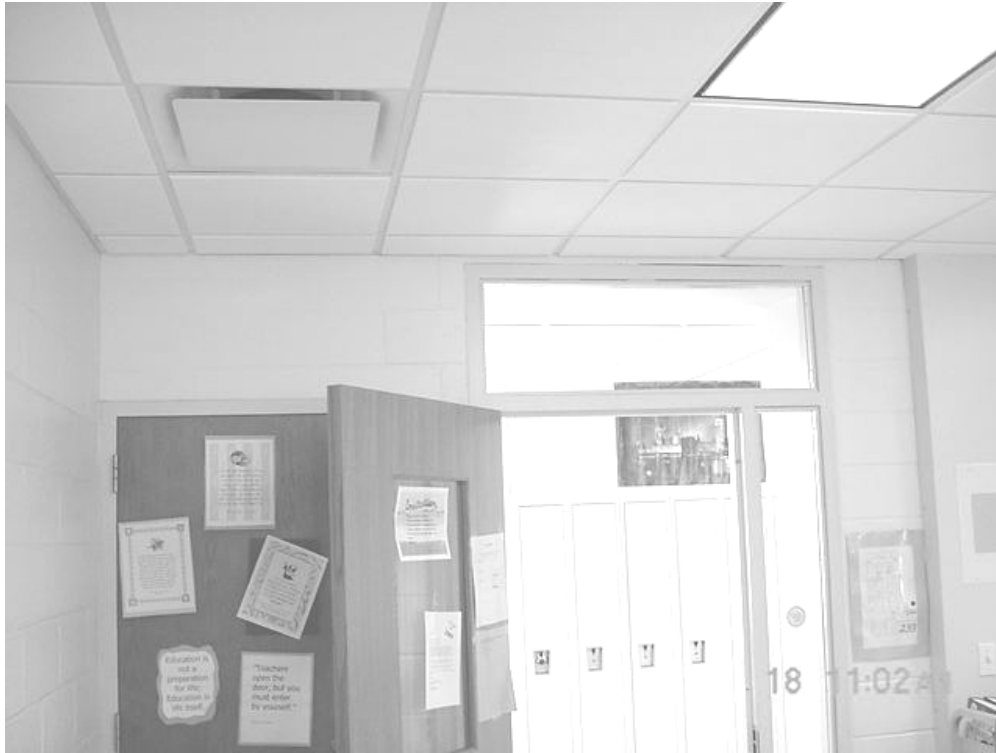
Picture 4

The mechanical exhaust ventilation system consists of ceiling-mounted exhaust vents connected to rooftop motors. This system was operating during the assessment. However, the location of some exhaust vents, near hallway doors, can limit exhaust efficiency when classroom doors are open (Picture 4). When a classroom door is open, exhaust vents will tend to draw air from both the hallway and the classroom. The open hallway door reduces the effectiveness of the exhaust vent to remove common environmental pollutants from classrooms.

Ceiling Exhaust Vent Near Open Classroom Door

3. To maximize air exchange, the BEHA recommends that both supply and exhaust ventilation operate continuously during periods of school occupancy independent of classroom thermostat control.

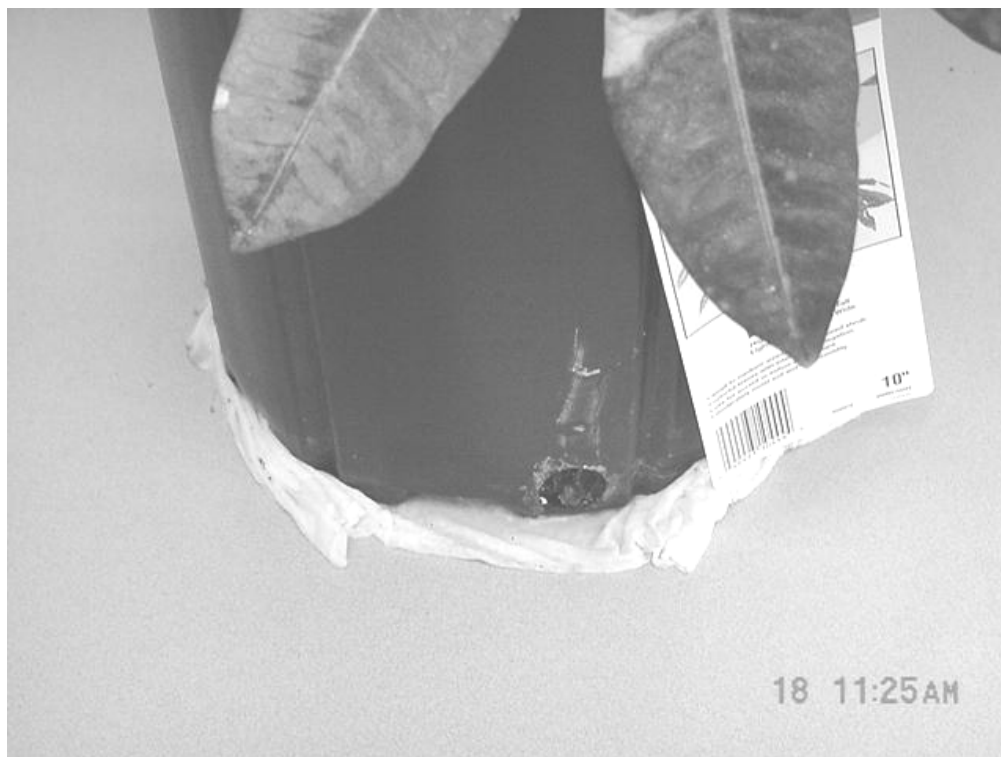
Picture 6

Several classrooms had a number of plants. Moistened plant soil and drip pans can be a source of mold growth. Classroom 214 had plants on top of paper towels that were saturated with water (Picture 6). Plants should be equipped with drip pans. Paper plates and towels are porous materials that can be colonized by microbial growth, especially if wetted repeatedly. In addition, the lack of drip pans can lead to water pooling and mold growth on windowsills. Plants are also a source of pollen. Plants should be located away from the air stream of ventilation sources to prevent the aerosolization of mold, pollen or particulate matter throughout the classroom.

Plant on Saturated Paper Towels

8. Move plants away from univents in classrooms. Ensure all plants are equipped with drip pans. Examine drip pans for mold growth and disinfect areas of water leaks with an appropriate antimicrobial where necessary. Consider reducing the number of plants.

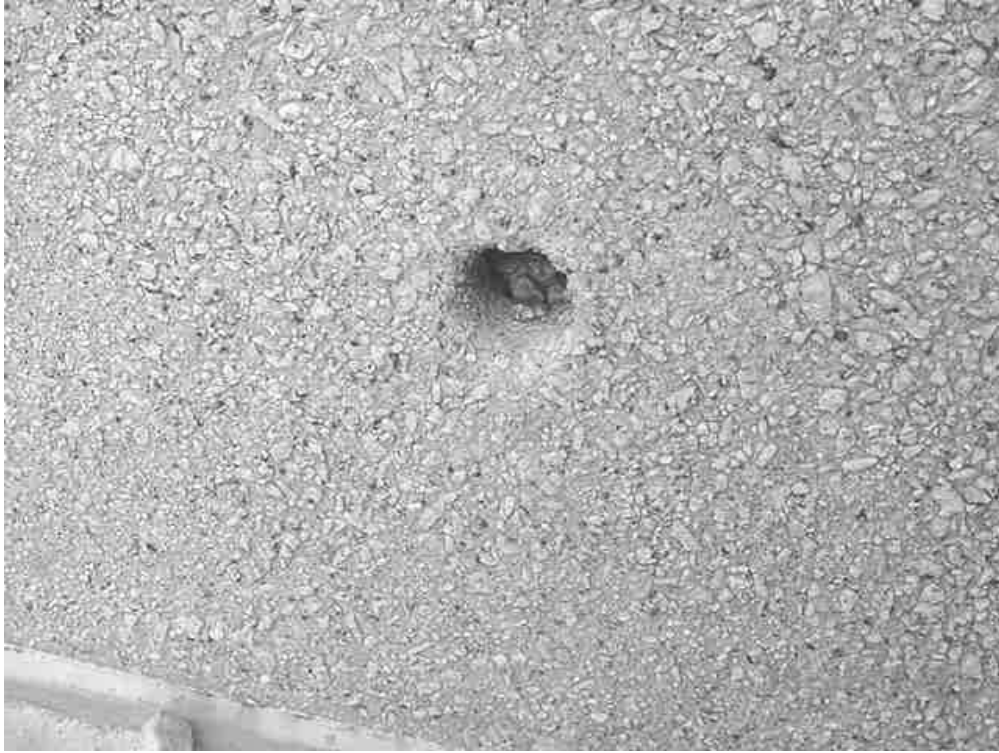
Picture 7

An open utility hole in the exterior wall (Picture 7), which can provide a potential pathway for moisture into the building was also seen. Repeated water penetration can result in the chronic wetting of building materials and potentially lead to microbial growth. In addition breaches in the building envelope may provide a means of egress for pests/rodents into the building.

Hole in Exterior Wall

9. Seal hole in exterior wall (Picture 7) to prevent water intrusion and entry of pests.
10. Clean chalkboards and dry erase board trays regularly to avoid the build-up of particulates.

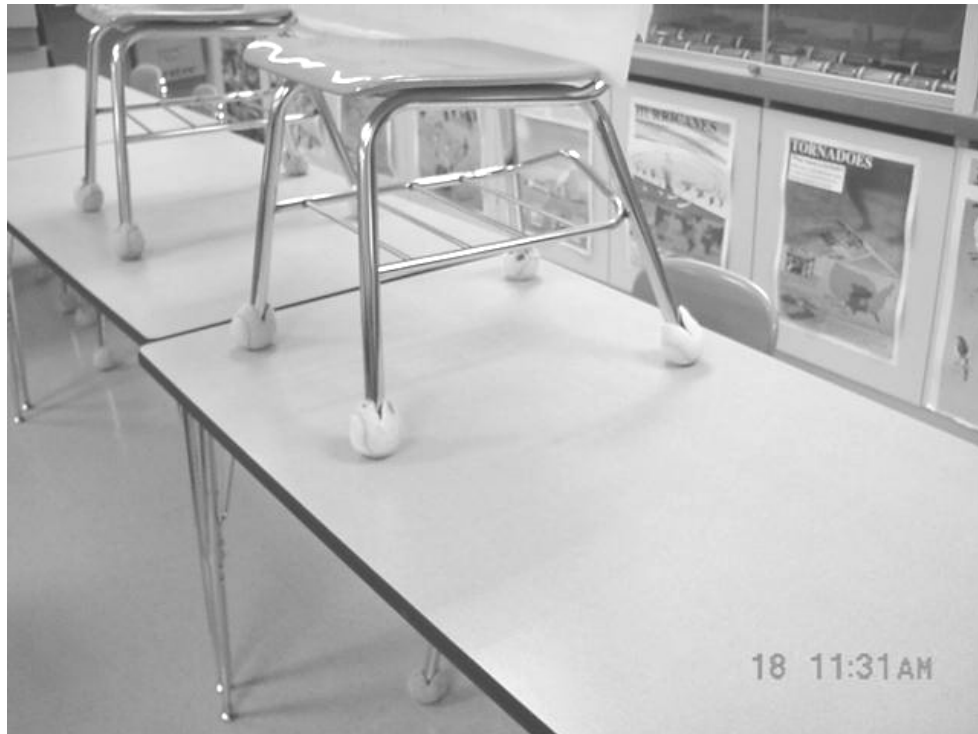
Picture 9

In an effort to reduce noise from sliding chairs, tennis balls had been sliced open and placed on chair legs (Picture 9). Tennis balls are made of a number of materials that are a source of respiratory irritants. Constant wearing of tennis balls can produce fibers and lead to off gassing of VOCs. Tennis balls are made with a natural rubber latex bladder, which becomes abraded when used as a chair leg pad. Use of tennis balls in this manner may introduce latex dust into the school environment. Some individuals are highly allergic to latex (e.g., spina bifida patients) (SBAA, 2001). It is recommended that the use of materials containing latex be limited in buildings to reduce the likelihood of symptoms in sensitive individuals (NIOSH, 1997). A question and answer sheet concerning latex allergy is attached as [Appendix II](#) (NIOSH, 1998).

Tennis Balls on Chair Legs in Classroom

13. Consider discontinuing the use of tennis balls on chairs to prevent latex dust generation.
14. In order to maintain a good indoor air quality environment on the building, consideration should be give to adopting the US EPA document, “Tools for Schools”. This document can be downloaded from the Internet at <http://www.epa.gov/iaq/schools/index.html>.

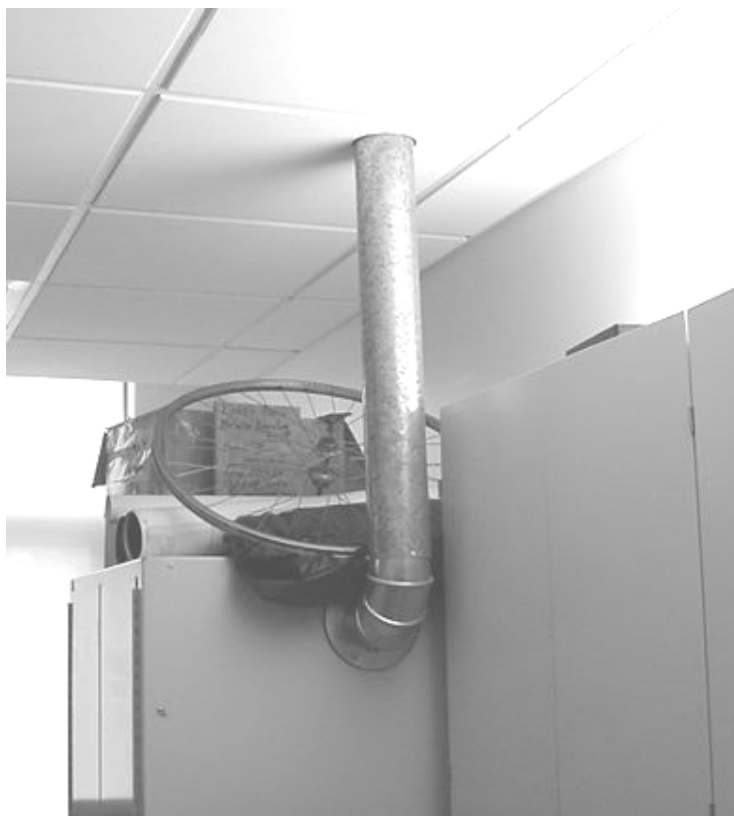
Picture 10

Finally, occupants expressed concerns relative to the adequacy of ventilation for the flammable storage cabinets (Picture 10). The National Fire Protection Association (NFPA) does not require venting in flammable storage cabinets. However, it is recommended that if a flammables storage cabinet is connected to a vent system, the vent system should not be constructed in a manner to provide an oxygen source to the interior of the cabinet and it must be vented directly outdoors and not in a manner which might compromise the specific performance

of the cabinet (NFPA, 1996). It could not be determined during the assessment if the flammable cabinet had a mechanical exhaust fan in the ductwork or a damper to prevent backdrafting.

Vented Flammable Cabinet in Science Prep Room

11. Clean exhaust/return vents periodically to prevent excessive dust build-up.
12. Determine if flammable cabinets are vented in a manner consistent with NFPA recommendations. If not, consider removing ductwork and seal cabinet to render airtight.
